CONTROL SURVEY
 FOR THE CITY OF JOHN DAY, OREGON
 IN SEC. 23 & 26, T13S, R31E.W.M.

DRW BY QLS, REV.	DATE: 7-9-66
WALLULIS & STAEBLER CONSULTING ENGINEERS P.O. BOX 91 PENDLETON OREGON

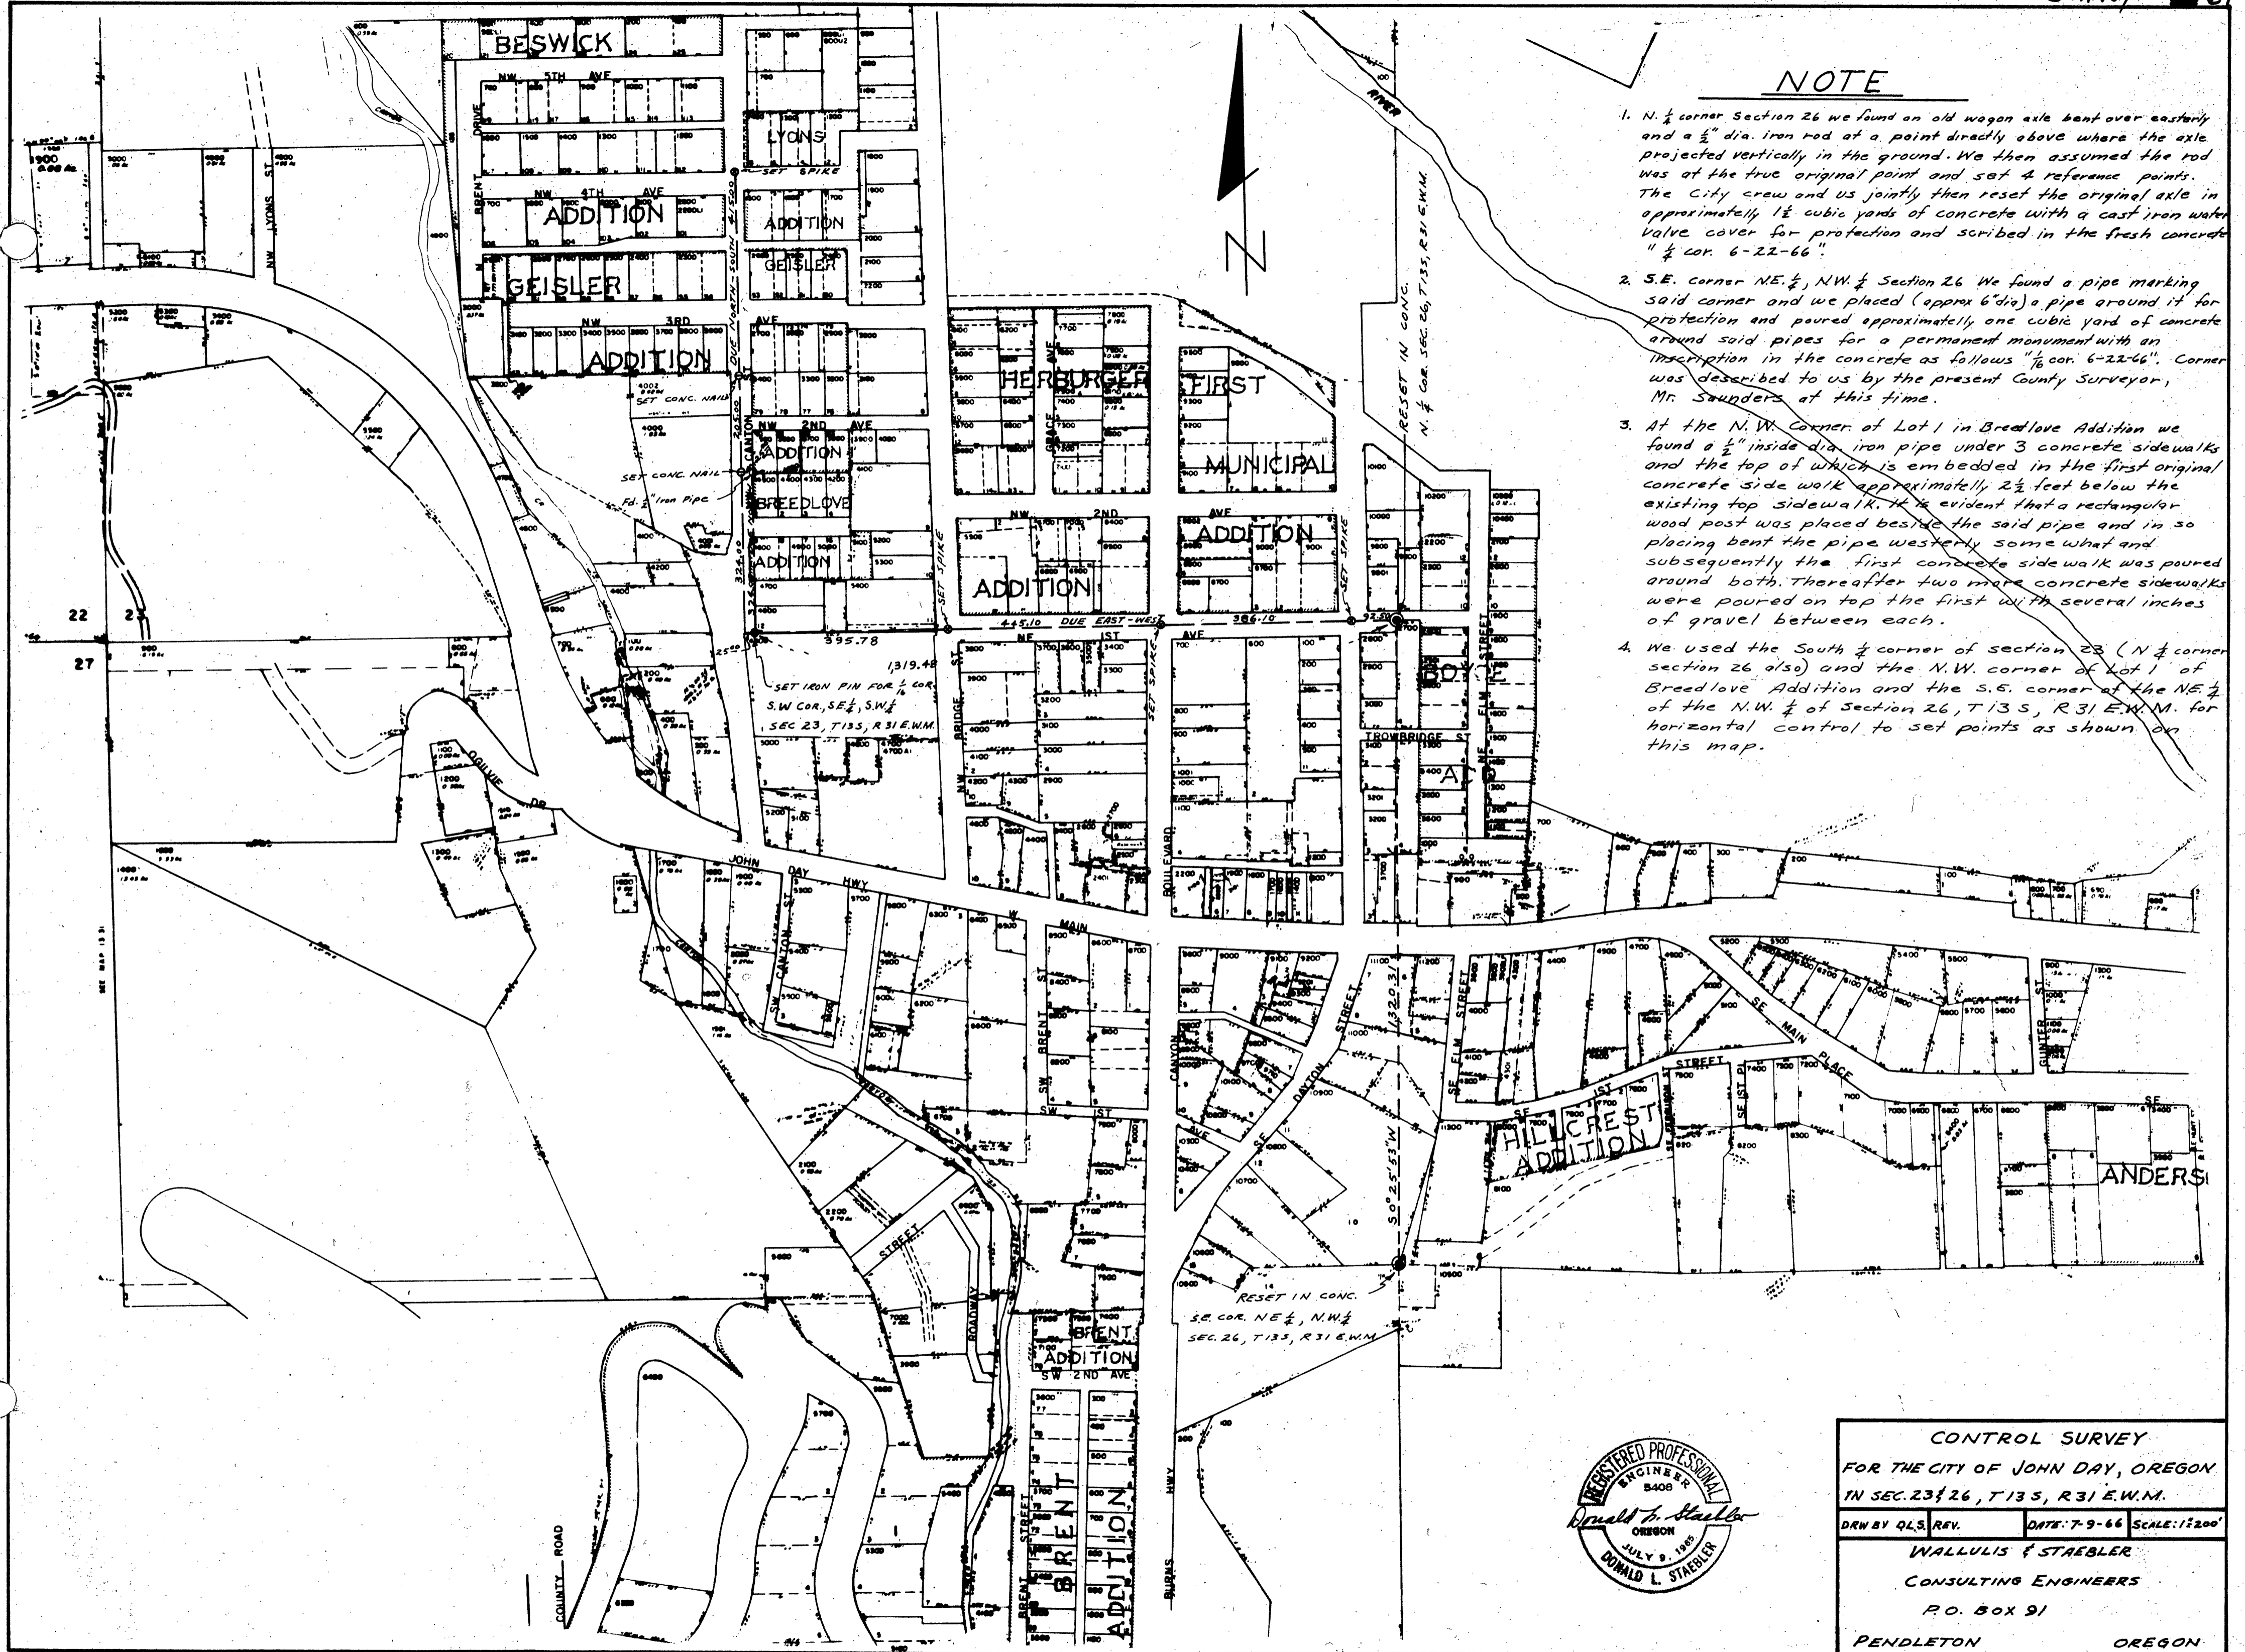
1. N. 1/4 corner Section 26 we found an old wagon axle bent over easterly and a 1/2" dia. iron rod at a point directly above where the axle projected vertically in the ground. We then assumed the rod was at the true original point and set 4 reference points. The City crew and us jointly then reset the original axle in approximately 1 1/2 cubic yards of concrete with a cast iron water valve cover for protection and scribed in the fresh concrete "1/4 cor. 6-22-66".

2. S.E. corner NE 1/4, NW 1/4 Section 26 We found a pipe marking said corner and we placed (approx 6" dia) a pipe around it for protection and poured approximately one cubic yard of concrete around said pipes for a permanent monument with an inscription in the concrete as follows "1/4 cor. 6-22-66". Corner was described to us by the present County Surveyor, Mr. Saunders at this time.

3. At the N.W. Corner of Lot 1 in Breedlove Addition we found a 1/2" inside dia. iron pipe under 3 concrete sidewalks and the top of which is embedded in the first original concrete sidewalk approximately 2 1/2 feet below the existing top sidewalk. It is evident that a rectangular wood post was placed beside the said pipe and in so placing bent the pipe westerly some what and subsequently the first concrete sidewalk was poured around both. Thereafter two more concrete sidewalks were poured on top the first with several inches of gravel between each.

4. We used the South 1/4 corner of section 23 (N 1/4 corner section 26 also) and the N.W. corner of Lot 1 of Breedlove Addition and the S.E. corner of the NE 1/4 of the N.W. 1/4 of Section 26, T13S, R31E.W.M. for horizontal control to set points as shown on this map.
